HAPHAZARD GROWTH OF HUMAN HABITATION IN AND AROUND NAINITAL, UTTARAKHAND, INDIA: ECOLOGICALLY UNBALANCED MAN-ENVIRONMENT RELATIONSHIP SCENARIO

Manisha Tripathi

Department of Geography, Kumaun University, Nainital-263002, Uttarakhand, India

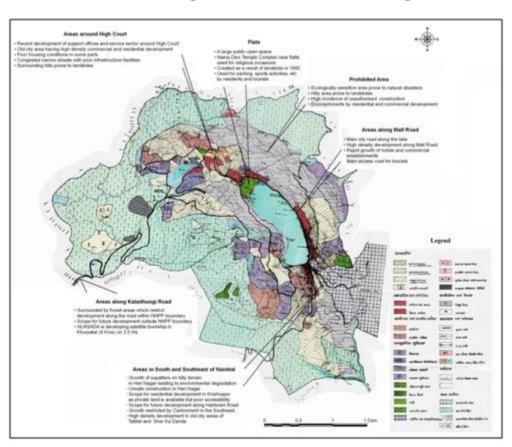
Figure 1 Nainital Resource Map (modified from Urban Development Directorate

Nainital lake region is gifted with a variety of aquatic ecosystems, especially a number of lakes that are of great scientific interest and economic importance in which Lake Nainital is one among the groups of lakes occurring in the southern fringe of the Kumaun lesser Himalaya. Lake Nainital forms a valley like feature at an altitude of 1934m asl extended in 29° 24′ N latitude and 78° 28′ E longitude. It is a 1.5 Km long crescent-shaped water body located along with the

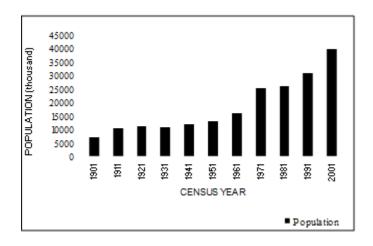
Figure 2 Decadal increase in population of Nainital

Population of Nainital town has tremendously increased during the past few decades. From 1961 to 2001 the population growth rate increased by 22.8 to 28.72.In last five censuses year the population is almost doubled from 16080 in 1961 to 39840 in 2001 shows the rapid growth of the town (the number temporarily swells during the summer months due to tourist influx). With the growth in population, particularly the municipal population (14995 in 1961 to 38559 in

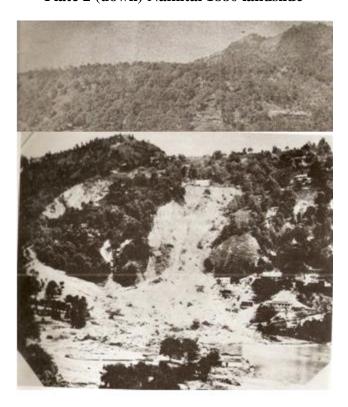
Plate 1 (up) Virgin land before 1880 landslide.

Plate 2 (down) Nainital 1880 landslide

The second catastrophe landslide occurred in 18^{th} September 1880 which was most tragic and destructive in the entire history of this region when the entire hillside of the Alma Dhar on the

The area of today's Nainital was covered with dense forests in the past (plate 1). This has protected the underground water level of the area. In addition, the overall ecological balance was maintained due to this dense forest cover. Often the previously peripheral, forested areas became parts of holiday homes, resorts, rest houses and an urbanized holyday belt was developed around the lake. The rapid increase in land demand for human habitation and developmental process has caused severe changes in the landform of this area. The average rainfall density of the area got reduced due to the deforestation in the hill slopes and surrounding the lake. Gradually the water level of the lake started falling due to the decreasing rain fall density and increasing water demand due to increase in human resources.

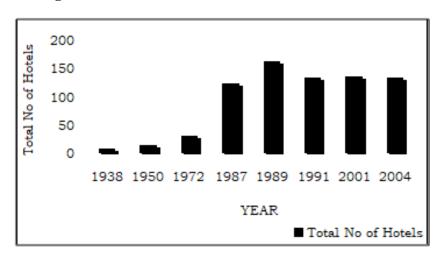
Figure 3 Increases in the total no of hotels in Nainital

In recent years, the great rush of migrated and floating population to Nainital and heavy urbanization along with the burden of local residents has experienced the rise of multistoried hotels almost after two three buildings, particularly on mall road and on the Sher-Ka-Danda ridge. A huge government complex is under construction on the way of Hanumangarh area and other is in the premises of Uttarakhand High Court. It is not a proper decision because the entire area is situated on the most effective seismic zone where heavy constructions are not permitted. The Nainital hill encompasses a rock succession that includes granites and the sediments and have thrusted over shiwaliks along the main boundary thrust (MBT). The MBT is tectonically very active and is manifested in large-scale hillside instability in the region (Valdiya 1988).

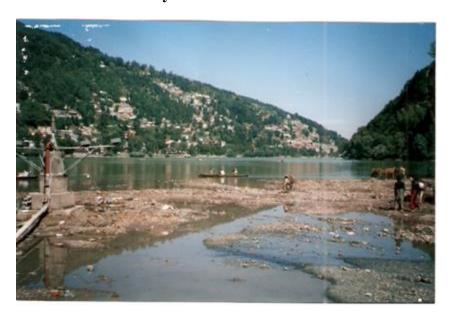
Plate 5 All the tourist and shop waste are dumped directly in the lake and finally find their way into the lake waters

The Nainital lake has acted as a sedimentation basin as indicated by the large debris fans and growing deltas (Plate 5) the town site were planned without taking the environmental hazards into account in spite of the clear geomorphic indicators of past landslides. Due to the removing of the earth, various deltas have been formed in the lake as the earth is flowing from the hills to the lakes (plate5 and 6). No attempt whatsoever has been made to stop the causes of siltation and now human and organic pollution, the latter due to open bazaar drains and uncontrollable garbage and waste from the roadside mushrooming shops, restaurants, recreation centers and hotels. Sewage systems are still not installed widely over here and untreated and partially treated effluents are discharged into the lake directly. Filthy row of shops and eating-houses right above the slope along the right side of the lake ensures that all the tourist and shop waste goes directly into the lake waters.

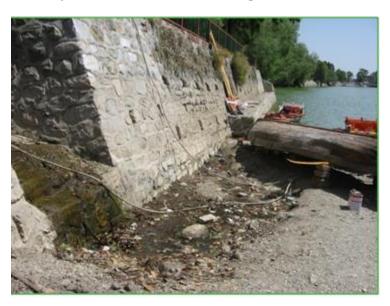
Figure 5 Total tourist arrivals in Nainital

It has been observed that with the exception of 1995, 1996, 1998 and 1999, all the years registered increase in the number of tourists. In reality the number of visitors has been growing uncontrollably and the development of the infrastructure has not been able to keep up with the growing popularity of the lake, leading to crowd and traffic problems in the season as well as otherwise, and a deteriorating image in general. Taking the tourist population of 2005 (5.18 lakhs) as the base, the average days of stay per tourist as 15 the average tourist load per day works out to 34,533. The educational institutions, training institutions and the university together account for approximately 16,000 population. The estimated number of population visits the town for official business is around 5000. Thus, the total number of floating population in Nainital town works out to 56,000 in 2005 (CDP, 2007).

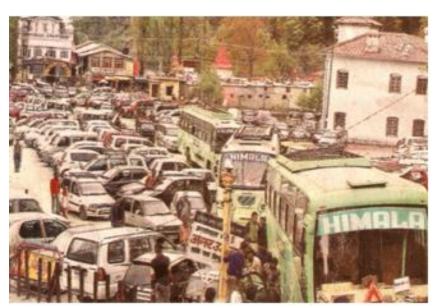
Plate 7 Traffic congestion during peak summer season in Nainital

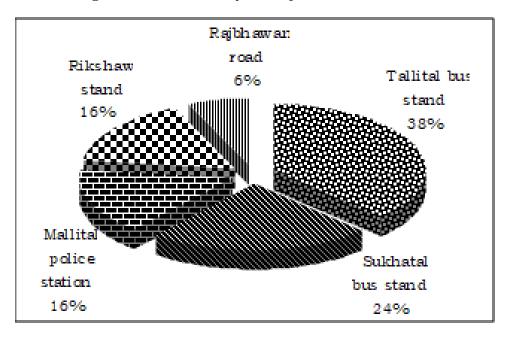
Figure 6 Traffic density on major routes in nainital

The main road of small-township is highly congested during the main tourist season, and opening of the schools and the number of vehicles passed through the main roads (mall road and governor's house road) varies from 314 to 502 a day (Figure 6).

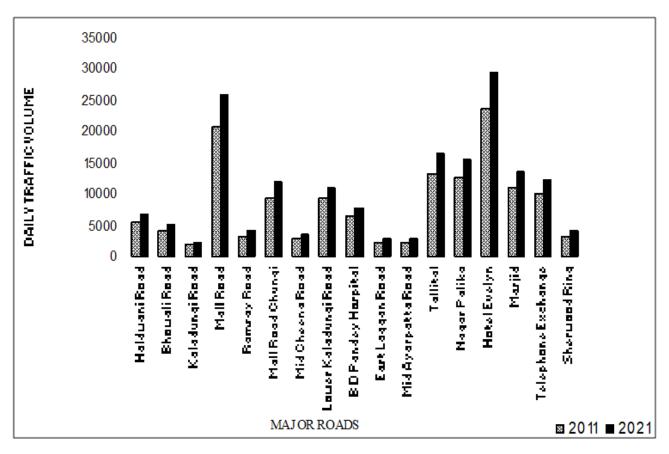
Figure 7 Decadal differences in existing and projected traffic volumes in Nainital

The road going to High-Court from Mallital Fields has witnessed unprecedented slummification despite the State Government laws. With the increase in tourist and local population, the number of vehicles is increasing year by year. In 2001 the estimated motor vehicles in Nainital was 3,650. The floating population in the town in comparison to its population is very high. Same in the case of vehicular traffic flow, which is also very high (Plate7), and so the congestion and traffic pressure will become a very big problem in near future (Figure 7).
